# Important Notes for Specific Pistol & Rifle Cartridges

## Notes for .40 Glock, .380 Bodyguard, Ruger 380s, and Beretta F9

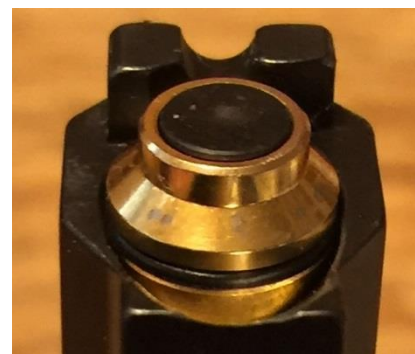
In all the above models, our laser cartridges may hit from ½" to as much as 2" above POA (point of aim).

The issue is caused by the undercut or "unsupported" chamber the manufacturers use in these models, as shown in the S&W Bodyguard photo at right. Unfortunately, the relieved area is exactly where the rear ring of the cartridge would engage the chamber – leaving it unsupported and tipping the point of aim upward. The relief cut seems to be deeper in older Glock models.

An ad-hoc fix that allows the cartridge to hit point-of-aim in affected models is to remove the rear neoprene ring and wrap a single layer of transparent tape (not overlapped) even with the top of the cartridge. If you damage the ring, we will replace it at no charge.
